PROPERTY INSPECTION REPORT

Concerning: 9000 Excellent Service Lane, Honestville, TX 99999
(Address of Inspected Property)

By: Brandon C Brown, #7424 01/01/1001
(Name and License Number of Inspector) (Date)

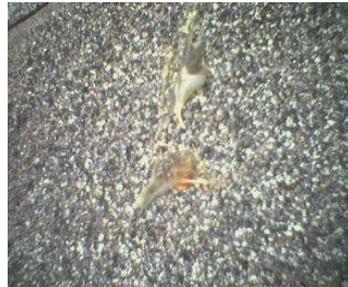
Roof: Exposed nail heads were noted in several locations on the roof ridges, flashing and at roof penetrations. Wood siding was in contact with the roof on the East side of house. Note: Wood siding should not be in contact with the roof due to the moisture from rain causing wood rot. Signs of wood rot were also observed at the siding on the East side of the house. Trim above gutter at rear patio not sealed. Corrections recommended.

Exposed nail heads

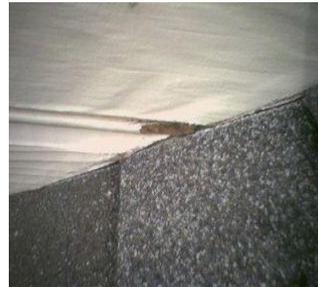
Siding in contact with roof

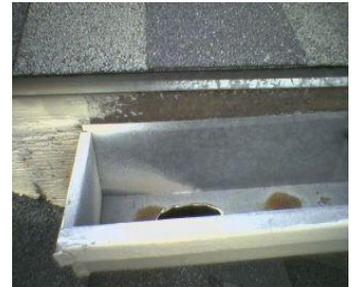
Unsealed trim above patio

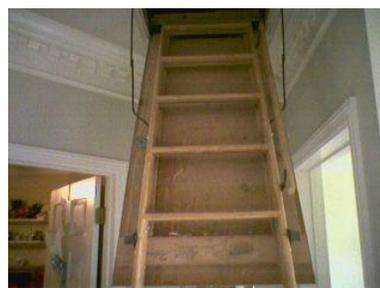
Insulation: Attic pull-down access door is missing insulation board. This is recommended to limit the radiant heat from attic penetrating into the home. Coverage for the rest of the attic appeared sufficient at time of inspection.

Missing insulation board at pull-down

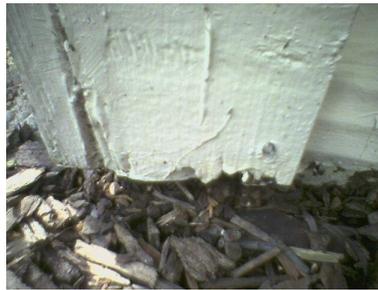
Exterior: On the West side of the structure, it was noted a lack of sufficient weep holes present. Weep holes are important in allowing moisture between the brick veneer and vapor barrier a method of draining. This will aid in keeping the framing members from absorbing the moisture and rotting. Wood rot was noted at the siding of the South bay window and also at the North wall below the living room window. There was a slight warping of the siding under the rear patio. Minor crack in brick veneer was noted at the Northeast bay window. Corrections recommended.

Wood rot at lower portion of siding

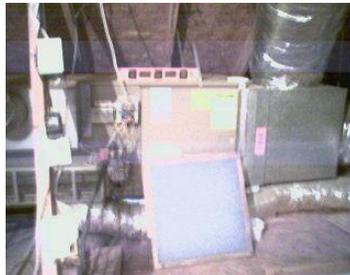
Evaporator: East unit is not level. Corrections recommended. No drain pan present on either unit. Secondary drain lines tied together in attic resulting in a single line at the exterior. Upgrading is recommended to allow condensate proper drainage.

AC unit out of level

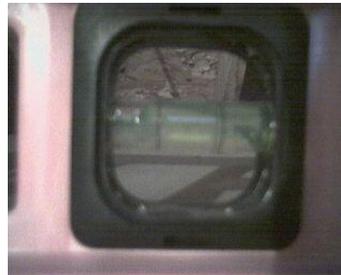
AC unit out of level

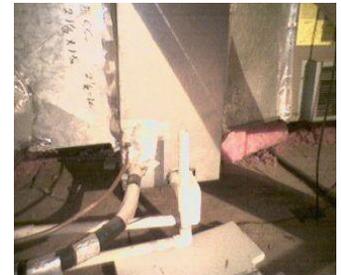
Missing drain pan

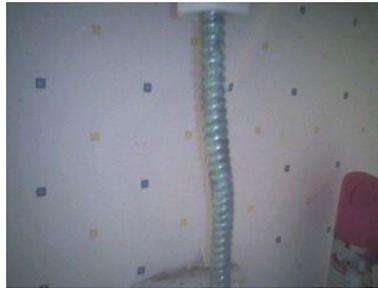
Toilet/Bidet Plumbing: Corrosion was noted under the toilet at water supply line in upstairs South bathroom. No leaks were present at time of inspection, further monitoring is recommended.

Corrosion at toilet supply line

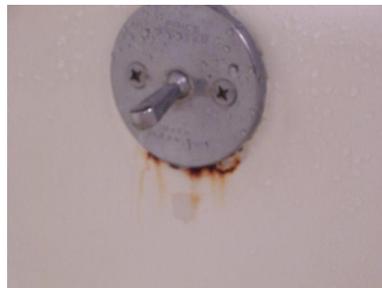
Rust at overflow drain

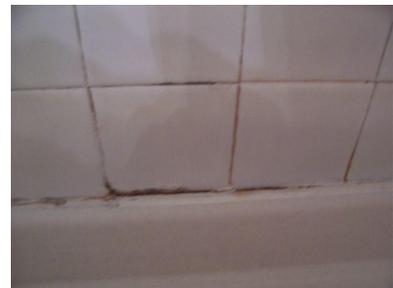
Tub/Shower Enclosure: Open grout joints were noted in the hall bath and master shower. Master shower tiles were soft to the touch. Further evaluation is recommended to determine the extent of damage to wall behind tiles. **Note:** Routine maintenance should be performed to keep the grout and caulk joints sealed to prevent water penetration.

Open grout in master shower

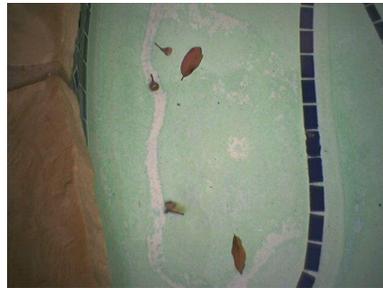
Gunitite surface was worn in several areas. Tiles were missing around pool trim below waterfall. Child safe pool drain not present.

Worn gunitite

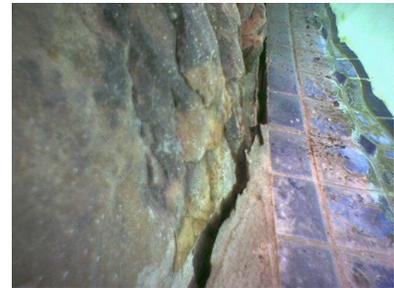
Cracked and missing tiles

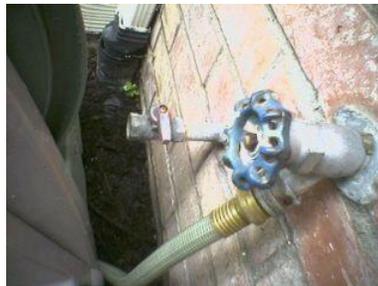
Exterior gas line on East wall is missing a cap. Corrections recommended. Also see comments in Fireplace/Chimney and Water Heating Equipment.

Uncapped exterior gas line
